# East New York Central Maintenance Facility (MTA-NYCT) Draft Upland Site Summary

# **EAST NEW YORK CENTRAL MAINTENANCE FACILITY (DAR SITE ID #7)**

Address:	1700 Bushwick Avenue, Brooklyn, Kings County,
	New York 11207
Tax Lot Parcel(s):	Brooklyn Block 3476, Lot 10
Latitude:	40.678576
Longitude:	-73.900976
Regulatory Programs/	
Numbers/Codes:	USEPA ID No. NYD981140023, PBS No. 2-609106, AFS No.
	3604701049, NYSDEC Spill No. 0901530 and 0708196
Analytical Data Status:	Electronic Data Available Hardcopies only

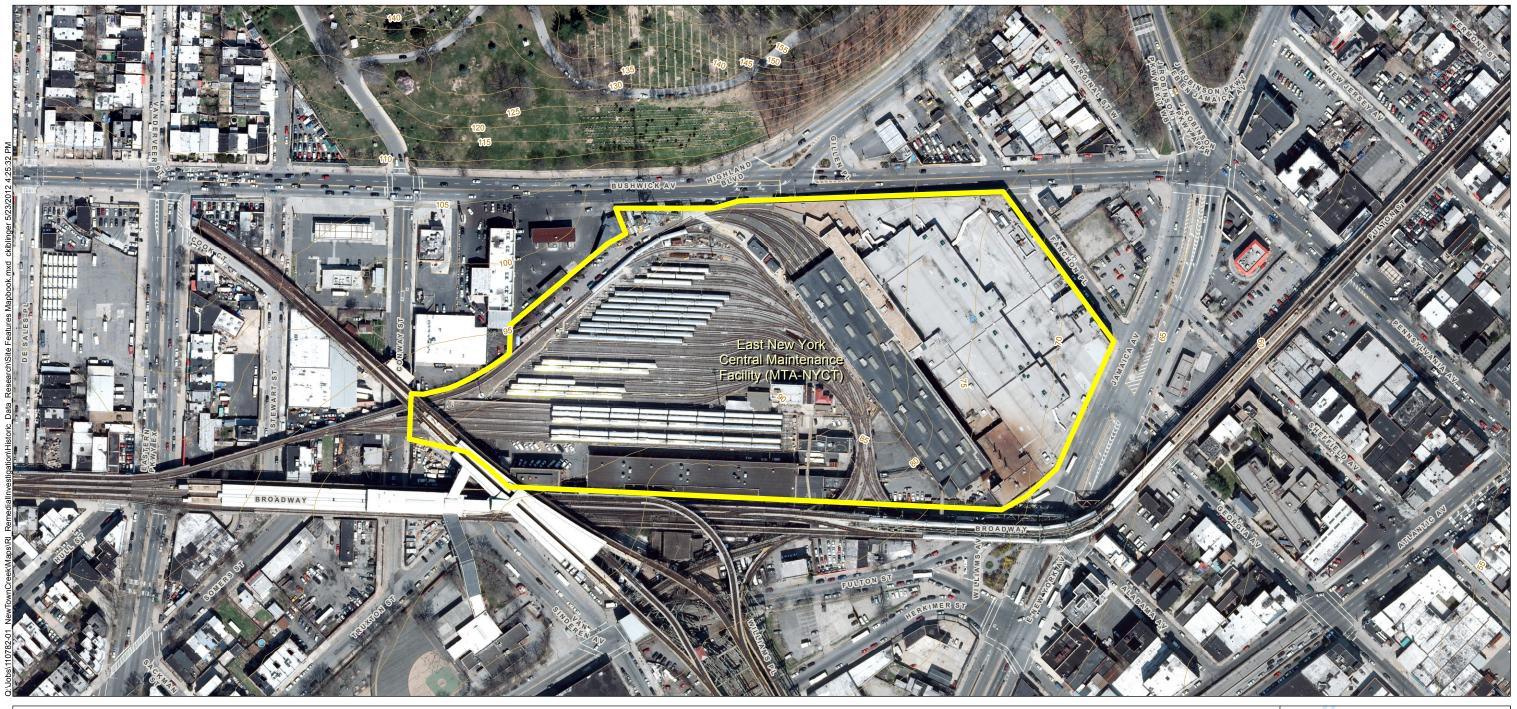
Figure 1 Site Vicinity Map: East New York Central Maintenance Facility (MTA-NYCT)

The site is zoned for manufacturing and surrounding land uses include a combination of manufacturing, commercial, residential, and park uses as shown in Figure 1.

9.3.1	Stormwater and Wastewater Systems		
Infori	nation regarding on-site stormwater infrastructure	and management wa	s not identified
in doo	uments available for review. This site is located o	utside of the Newtow	n Creek WPCP
sewer	shed (NYCDEP 2007), approximately 2.45 miles fr	om Newtown Creek a	and associated
water	ways. Based on the site topography, stormwater a	the site is expected t	o infiltrate into
the gr	ound or flow overland towards the south onto the	adjoining properties	(see Figure 1).
